Uncovering Poorly Performed Cosmetic Dentistry

An All-Ceramic Case Report

Frank J. Milnar,
DDS

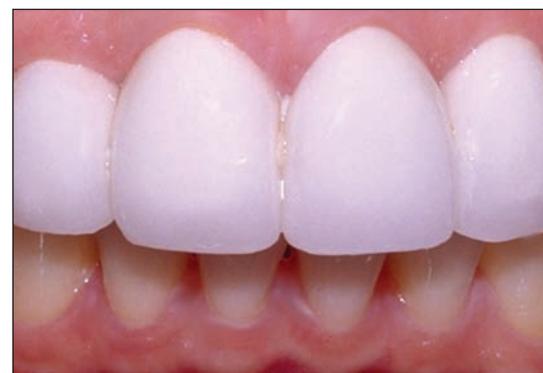
A 37-year-old female presented following the placement by a "cosmetic" dentist of 4 new all-ceramic crowns on her anterior maxillary dentition (Figures 1 and 2). She was emotionally distraught and upset over the aesthetics, contour, and overall appearance of the restorations, especially since a friend told her they looked like "denture teeth." She admitted that the previous dentist did not educate her about the types of materials that could be used to fabricate the crown restorations, nor did he explain aspects of color matching or determining the appropriate size and shape of the crowns. She explained that her natural teeth were discolored, which was the reason she originally sought cosmetic restorations.

Figure 1. Closeup preoperative view of the patient's 4 maxillary all-ceramic crown restorations that had been recently placed by a "cosmetic" dentist.

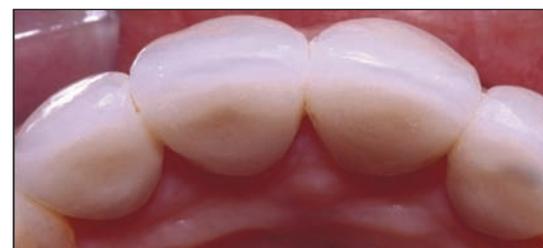
Figure 2. Preoperative incisal view of the patient's original all-ceramic restorations demonstrating the excessive thickness and contour of the restorations.

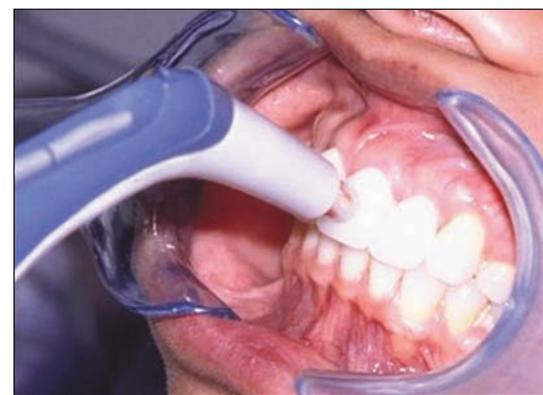
Figure 3. A spectrophotometer was used to develop a custom shade for the patient's new all-ceramic restorations.

taken using a spectrophotometer (Vita Easyshade [Vident]) and conventional shade mapping, and she would have input into the shade she desired (Figure 3). Combined, these 2 methods would enable the clinician to work with the laboratory to establish the tooth shade in terms of its value (ie, brightness), chroma (ie, color intensity), and hue (ie, basic color based on wavelength of visible light).⁵ It would also allow the laboratory ceramist to ultimately apply the selected ceramic porcelains (Vita VM9 [Vident]) in such a way that they would appropriately influence the basic color and shade of anticipated restorations.⁵ Additionally, the patient was informed that a bisque bake try-in was recommended, as was custom staining of the crowns in the mouth, so that she could be involved in the aesthetic design of her restorations at every stage.

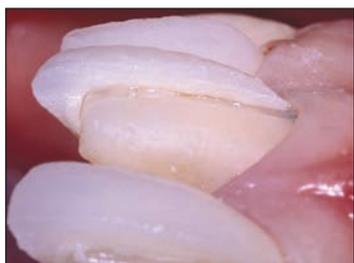
Figure 8. Cross-sectional view of the existing restorations to demonstrate the excessive ceramic thickness, particularly at the incisal edge.

The patient was anesthetized, and a series of burs (Brasseler USA) were used to remove the existing all-ceramic restorations. Bur cuts made into the facial, incisal, and lingual aspects of the restorations demonstrated the extent to which the restorations had been overbuilt (Figures 7 and 8).

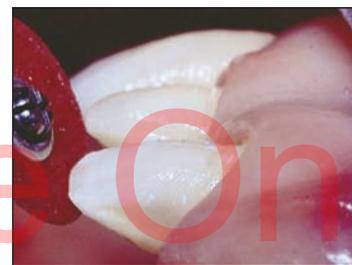
natomically corrected wax-up, it was necessary to reduce the incisal edge to allow sufficient clearance (Figure 12). The cord was removed, and a new polyvinyl siloxane impression of the preparations was taken.

Figure 12. The incisal edges were reduced to provide sufficient clearance for the provisional restorations.

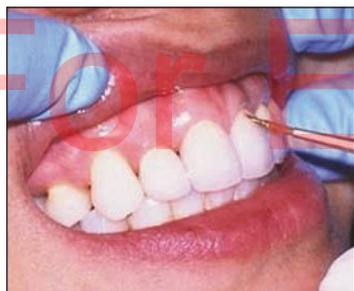
Figure 18. During the bisque bake try-in, custom stains were applied directly to the restorations while in the patient's mouth.

The bisque baked restorations were tried in, and the ceramist applied custom stains to the restorations while they were still seated in the patient's mouth (Figure 18). After all stains were applied and the patient approved of the aesthetics of the restorations, they were removed and left with the laboratory for final glazing and firing.

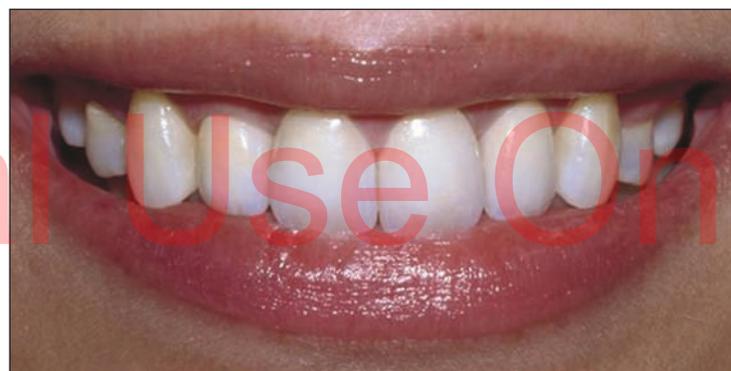
The crowns were tried in to verify the interproximal and centric contacts as well as marginal adaptation. However, this had already been established during the bisque bake try-in appointment, so no adjustments were necessary. For definitive cementation, zirconium-based restorations such as these may be placed using glass ionomers, resin-modified glass ionomer luting cements, or self-etching adhesive resin cements.¹¹ The internal aspects of the crowns were cleaned and dried, the cement loaded into them, and the crowns seated. Upon review by the patient, the final aesthetic restorative outcome completely satisfied her expectations and renewed her self-confidence in the appearance of her smile (Figures 19 and 20).

Figure 20. Postoperative view of the patient in natural smile. Note the natural-looking transition of the contours, color, and characterization among the restorations and her natural dentition.
